Confidential Inspection Report

LOCATED AT:
Client Address

INSPECTED ON:
Wednesday, 07 February 2024

Builders Snag List

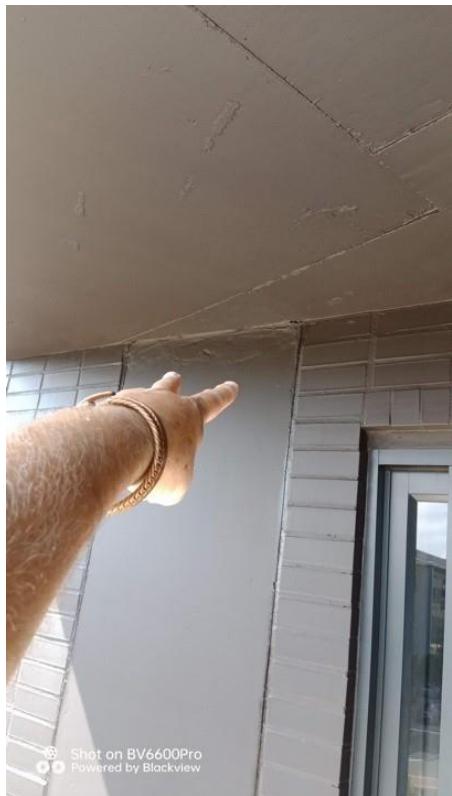
CORR s-23: Balcony external painted wall:

The portion of the balcony wall featuring painted plaster exhibits a noticeable lack of professional finishing when juxtaposed with the remainder of the exterior surface. We advise the removal of the existing plaster, followed by reapplication to align seamlessly with the surrounding wall. Subsequent steps should include priming and repainting for a cohesive and uniform appearance.

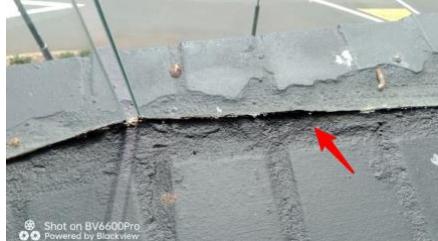
CORR s-29: The caulking at the base of the glass guard rail in our opinion was not professionally finished. We recommend the caulking be removed/cleaned and applied consistently and professionally.

Balcony Guard Rail - Caulking substandard

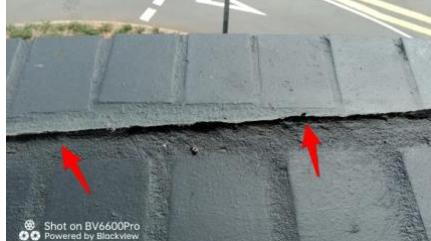
Balcony Guard Rail - Caulking substandard.

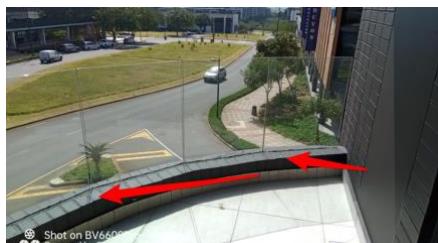
Balcony Guard Rail - Caulking substandard.

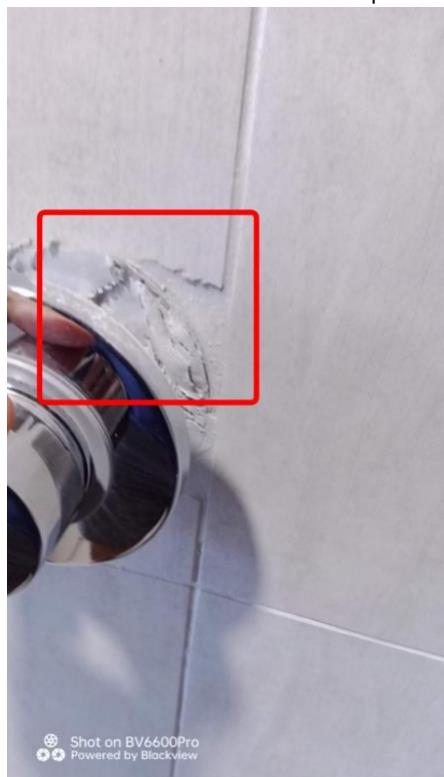
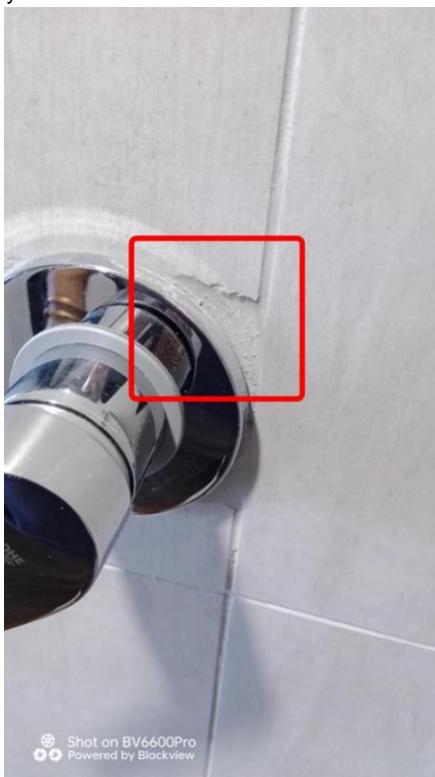
Spare bathroom shower

CORR **s-43:** There are one or more wall tiles that have not been professionally installed near the shower escutcheon. We recommend the tiles be removed and reinstalled professionally in this area.

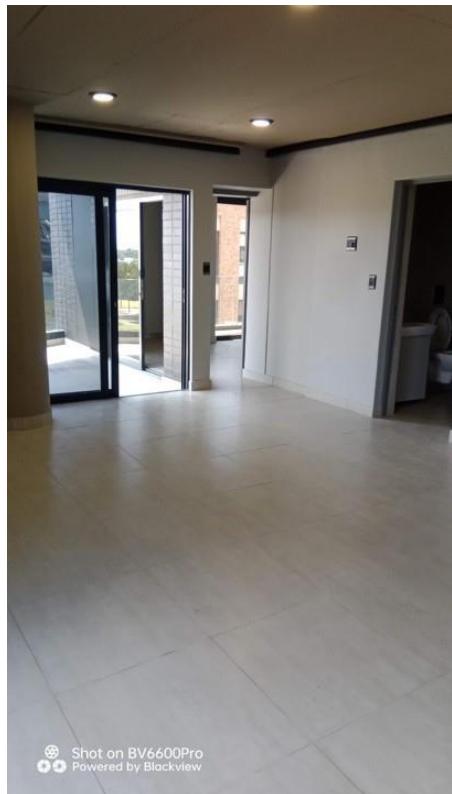
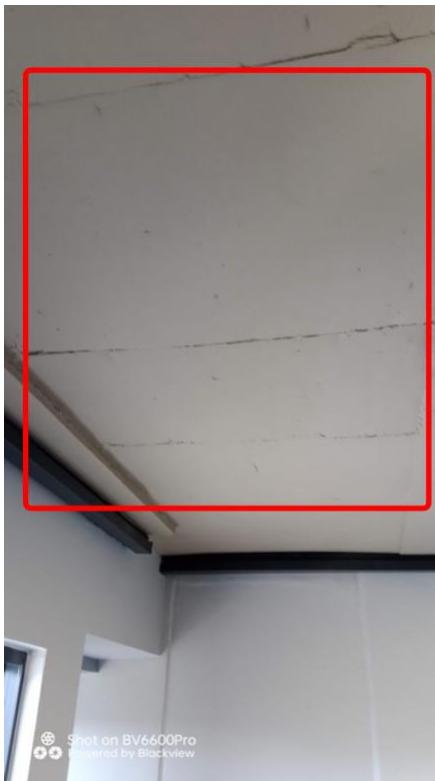
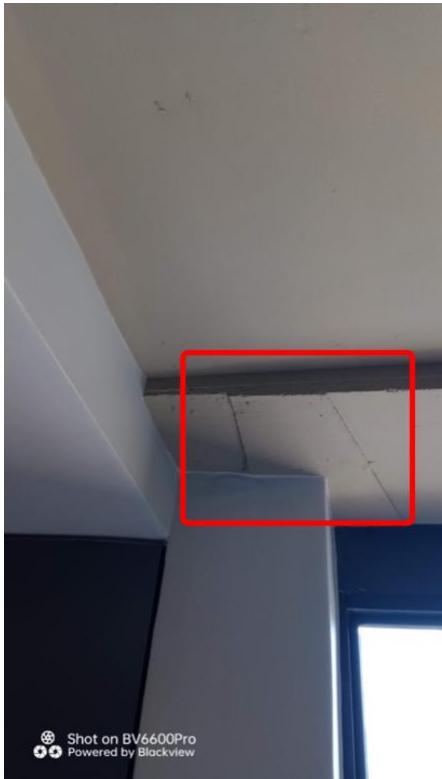
Main living area ceiling

CORR **s-46:** Significant irregularities are evident in the concrete slab.

The 'finished' ceiling, constituting the reinforced slab between the floors coated with paint, displays noticeable inconsistencies in its levels as noted by the inspector. The client should inquire with the builder/developer regarding whether these irregularities conform to the intended design specifications.

To achieve a more polished and aesthetically pleasing appearance, we recommend the installation of a suspended ceiling.

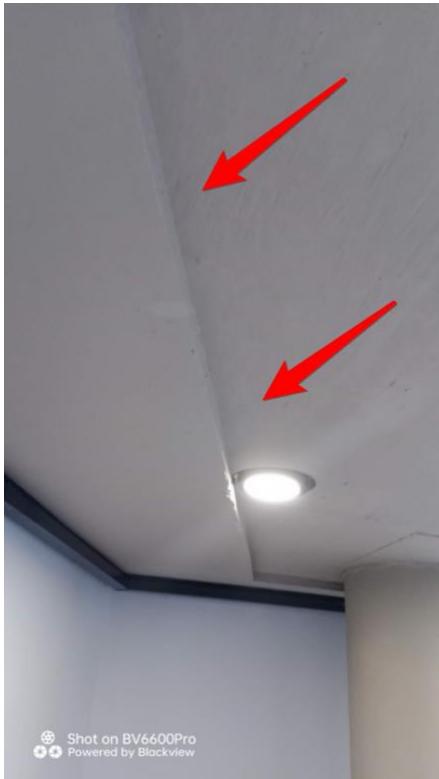
Stepped concrete ceiling

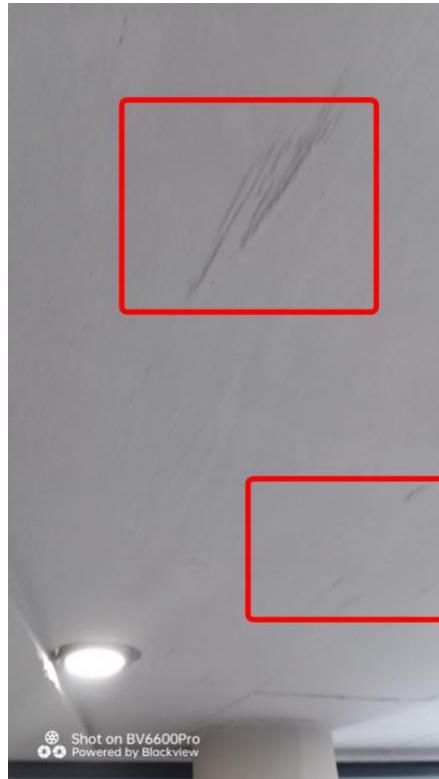
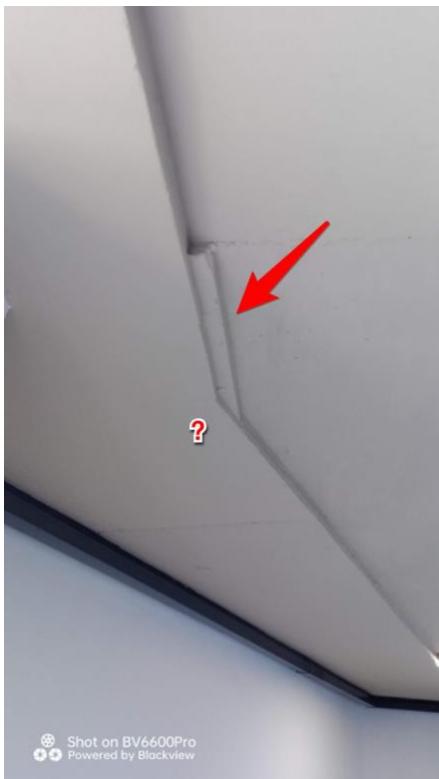
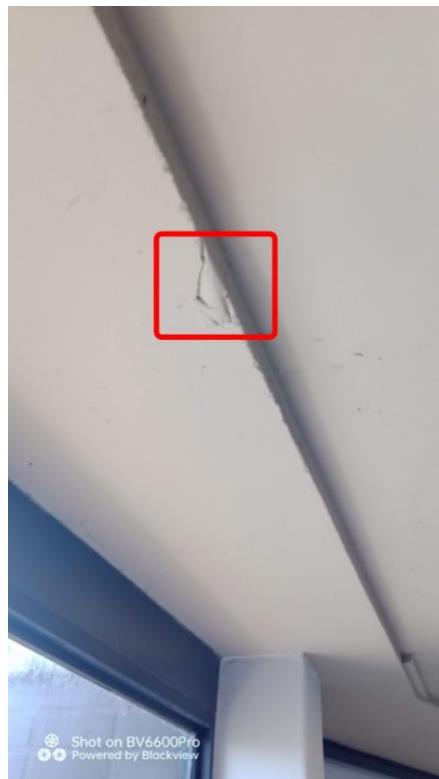
Ceiling Blemishes

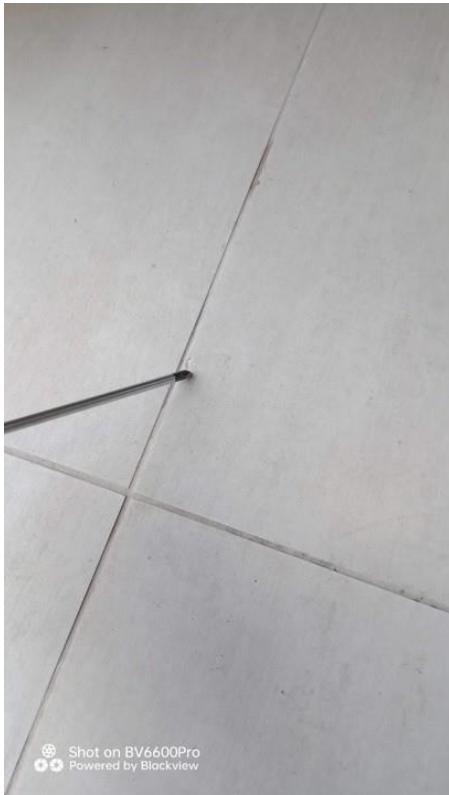
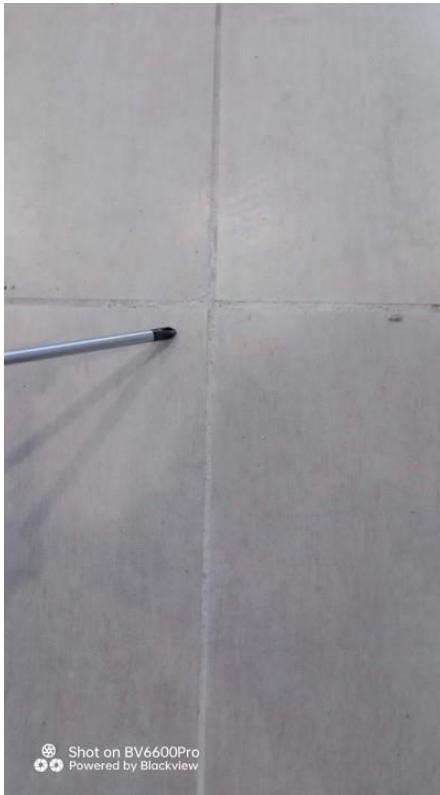
Main Living area - left facade

CORR s-49: Several tiles sound 'hollow' when walked on pointing to substandard preparation and installation of tiles. These tiles will be more likely to crack and break, therefore since repairing this issue is not possible, replacement is the only solution.

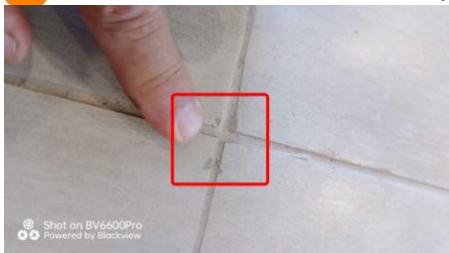
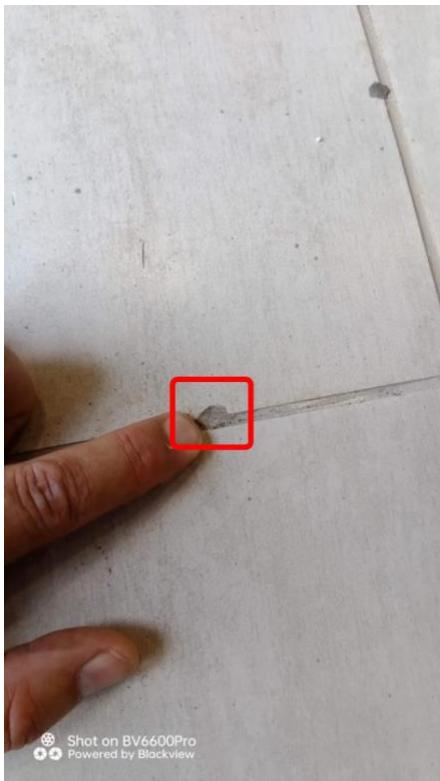
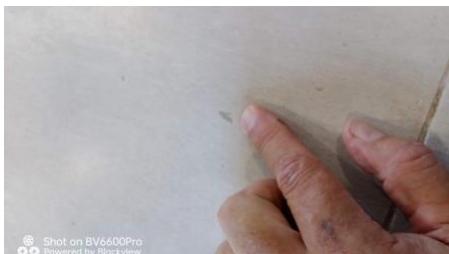
Paint splash marks on the finished tile.

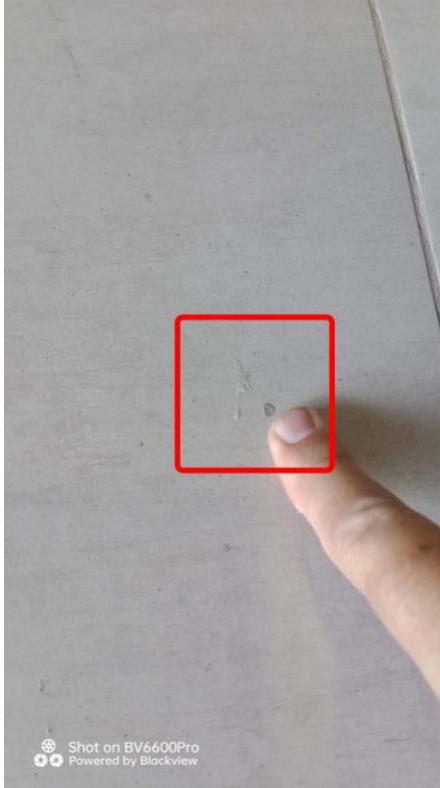
Paint splash marks on the finished tile.

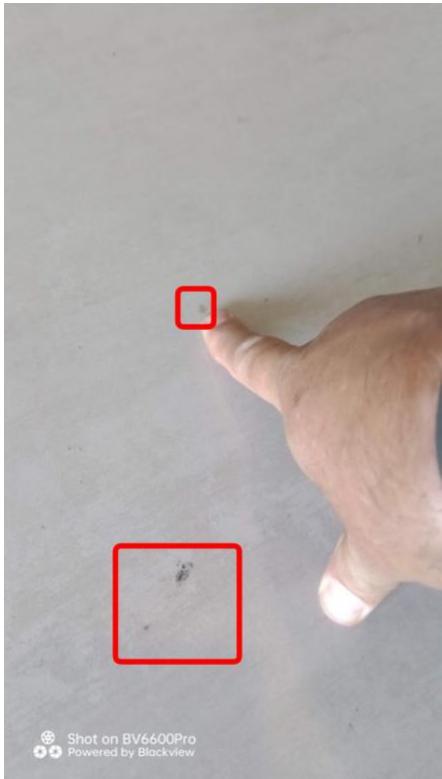
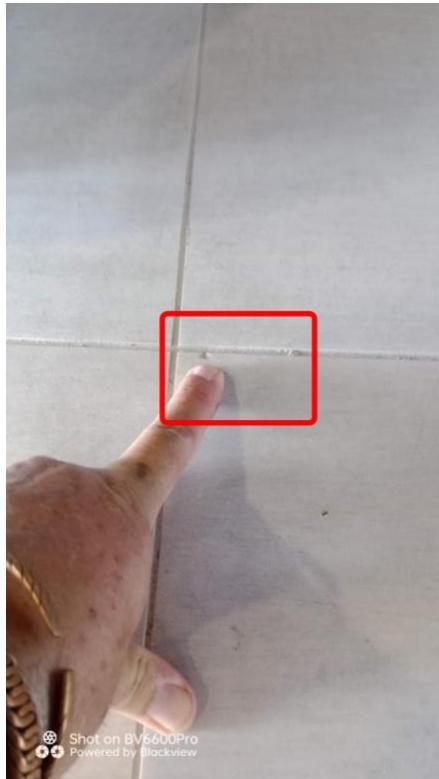
Paint splash marks on the finished tile.

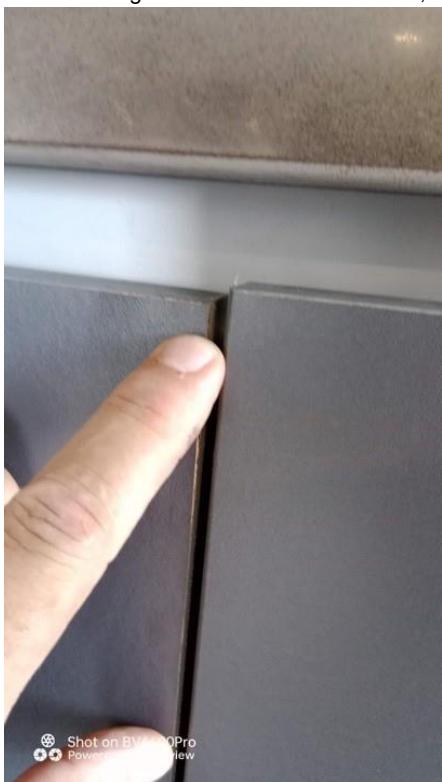
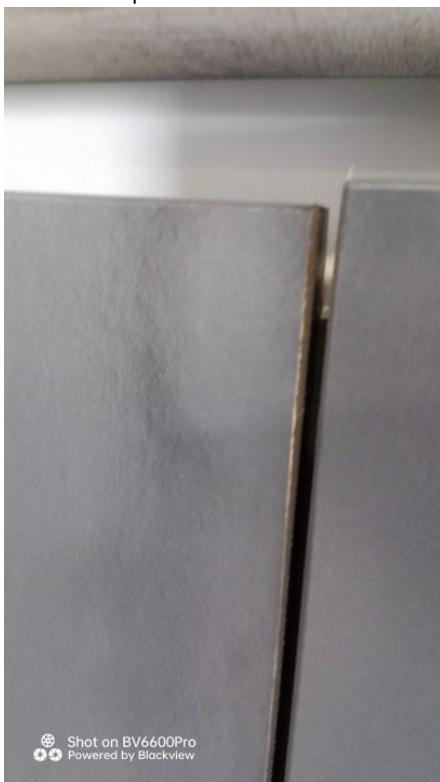
CORR s-52: One of the kitchen cabinets needs to be aligned for proper operation. It could be loose hinges and we recommend the door hardware in general needs to be checked, tightened and/or replaced.

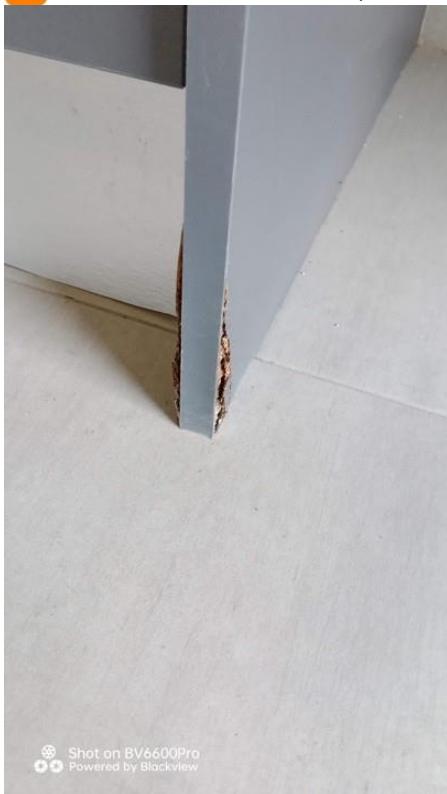
s-53: The cabinets and/or cupboards are damaged. We recommend repair to restore appearance and proper function.

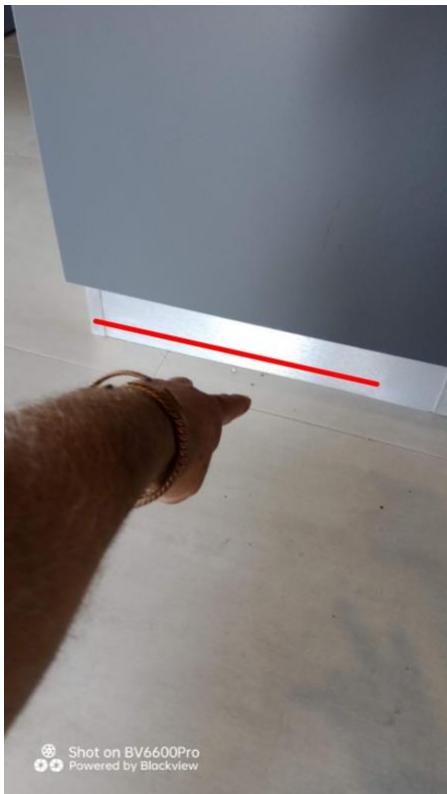
s-54: There are gaps between the cupboard and the kick plate under the cupboard, pointing to substandard installation or damage. We recommend adjustments are made if necessary and all gaps are sealed with a high-quality neutral cure sealant like 'Soudal Silirub 2'.

Kitchen kick-plate - seal off so no water damage occurs.

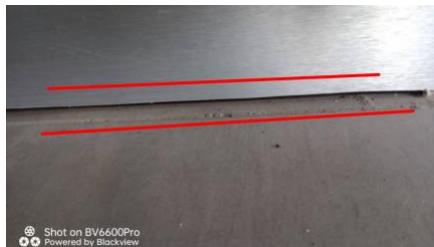
Kitchen kick-plate - seal off so no water damage occurs.

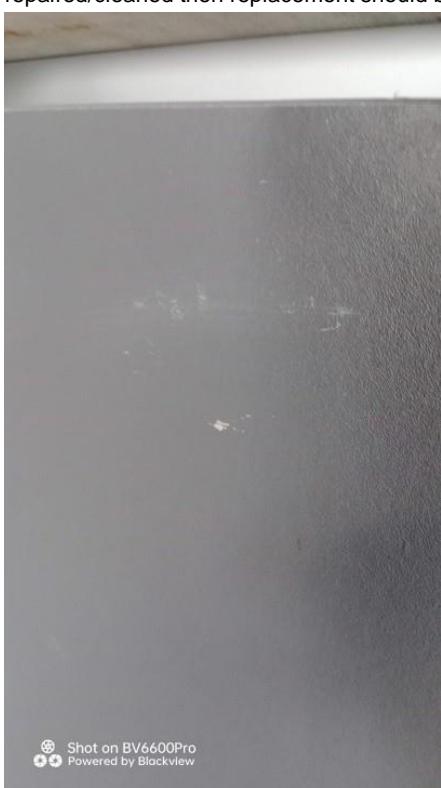
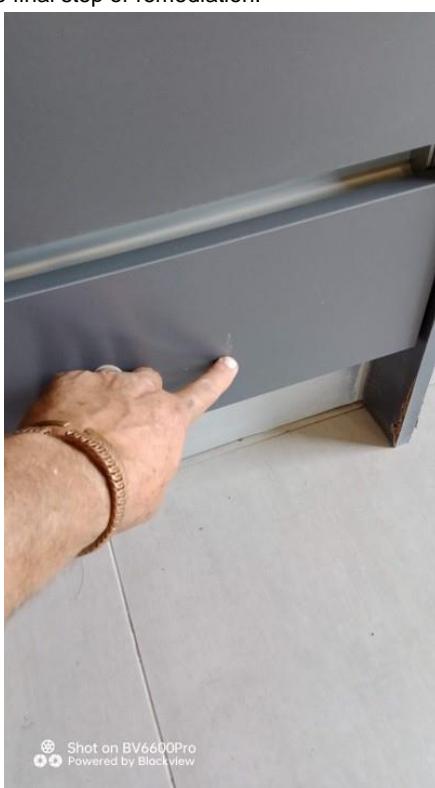
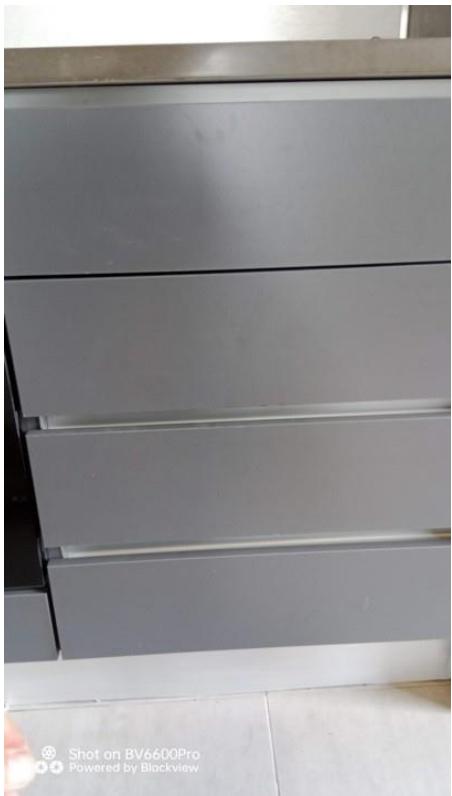
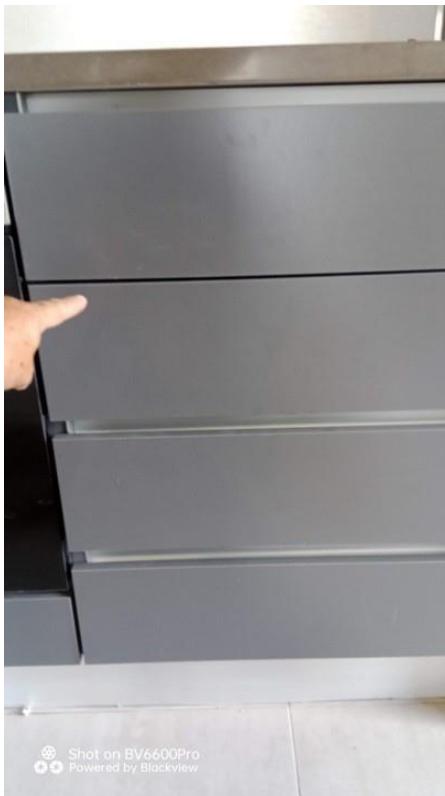
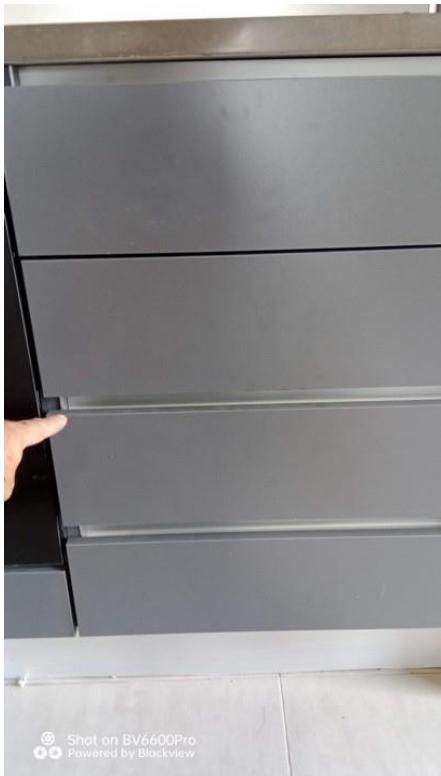
CORR **s-56:** Scuff marks on the kitchen cupboard.

The inspector noticed several scuff marks left behind by the contractors. As this is a new build and a snag list inspection, all building systems and components should be new. We recommend that all doors and or cupboards where scuff marks exist if cannot be repaired/cleaned then replacement should be the final step of remediation.

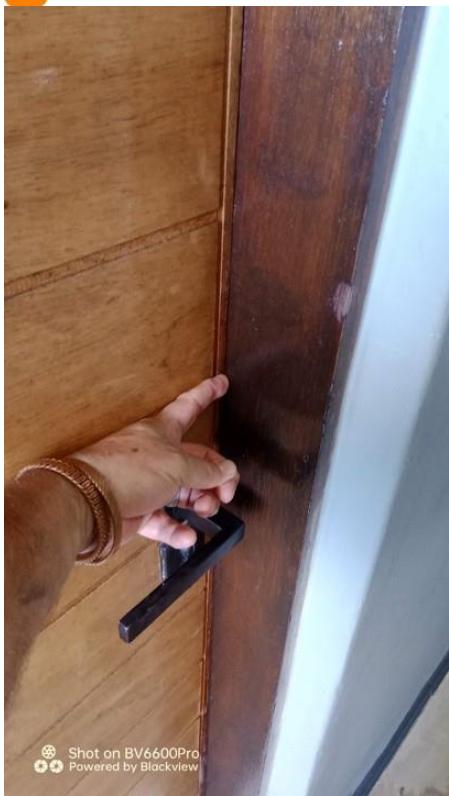
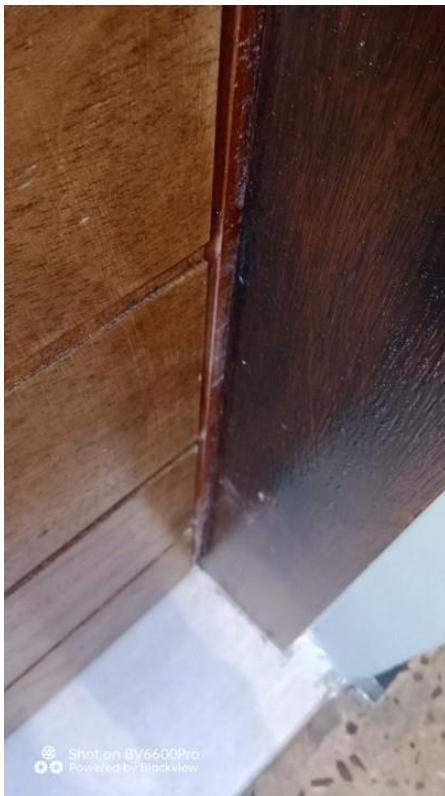
CORR **s-63:** Several of the doors are a poor fit and have uneven gaps. This is a common occurrence.

The front door is not aligned- rattles.

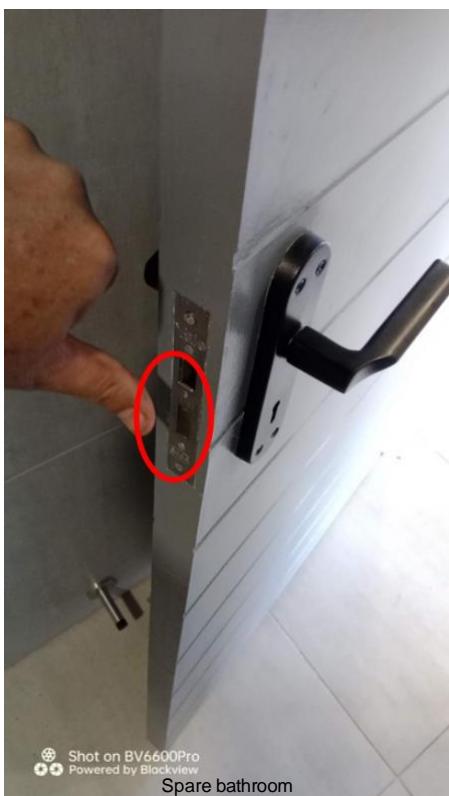
CORR **s-64:** There are one or more doors where hardware is faulty and needs attention, repair, or replacement.

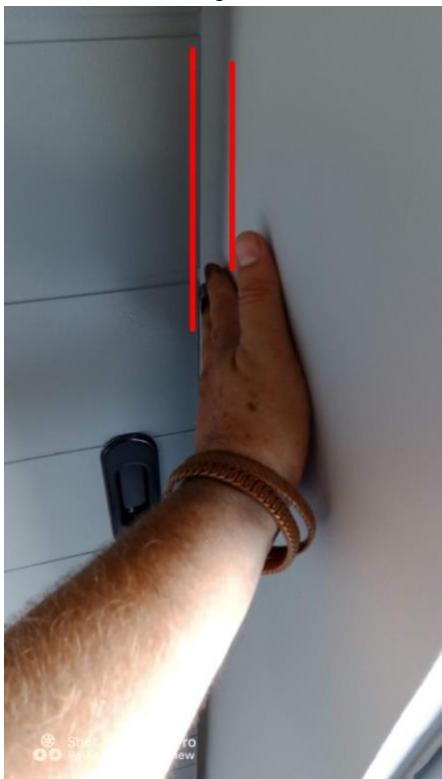
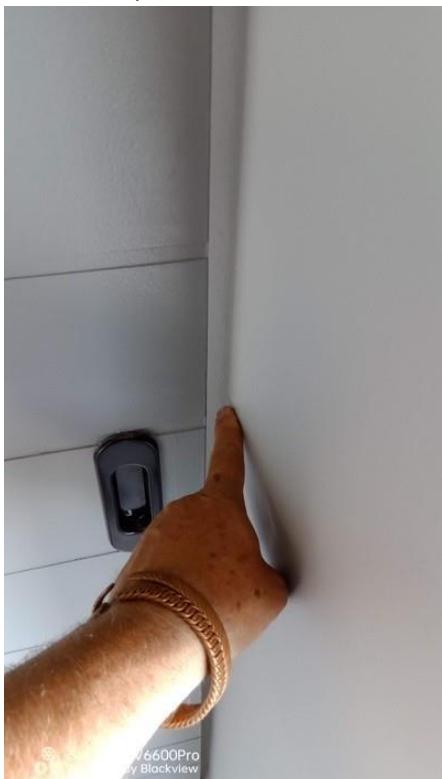
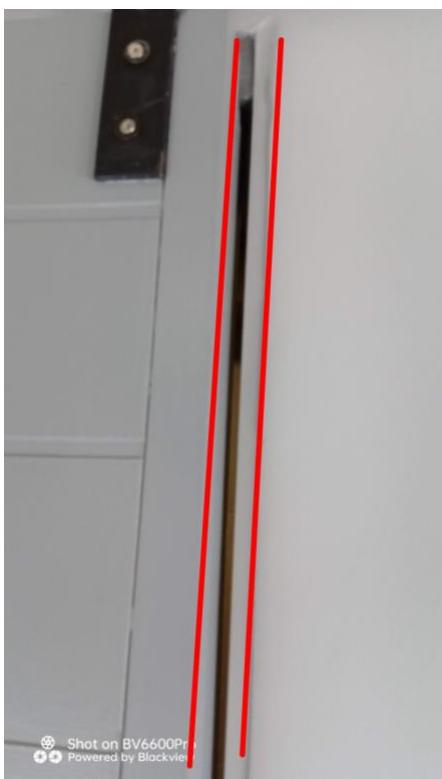
Master bedroom - barn door

The barn door leading into the master bedroom does not close tightly with the frame. There is approximately a 3/4-inch space between the frame and the edge of the door. We recommend this be repaired.

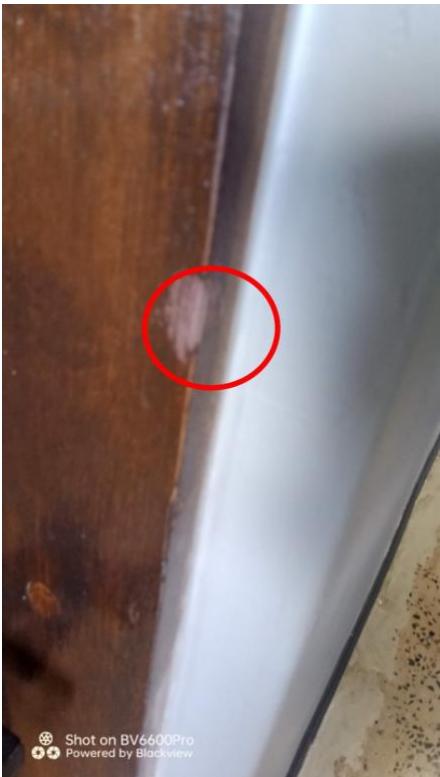
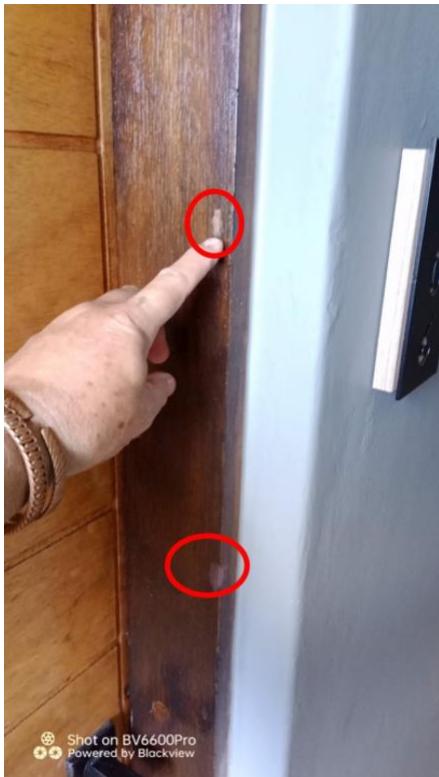
Front door

The inspector noticed several scuff marks on the wooden door frame. As this is a new apartment, we would recommend this be repaired by the developer.

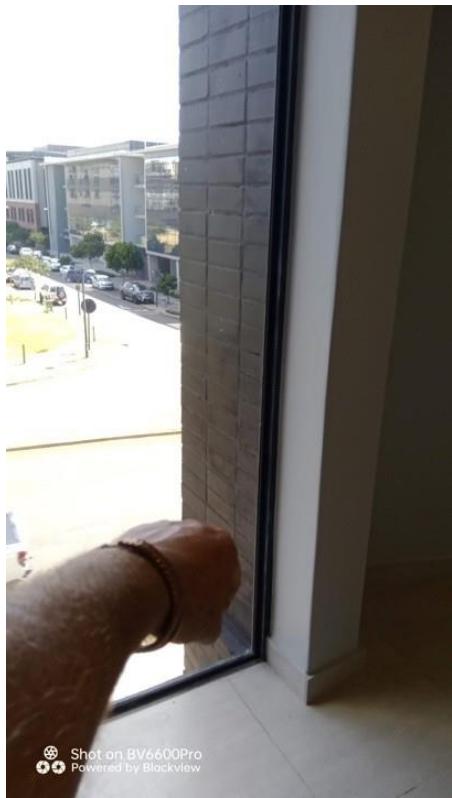
Main window - living area

During the inspection of the apartment, the inspector observed notable movement and rattling of the large windowpane, potentially influenced by the prevailing strong winds. Although the inspector's expertise does not extend to glass and frame assessment, it is highly recommended to consult an independent glass specialist for evaluation. This assessment is crucial to determine if the observed movement and vibration adhere to building standards and ensure the safety of the occupants.

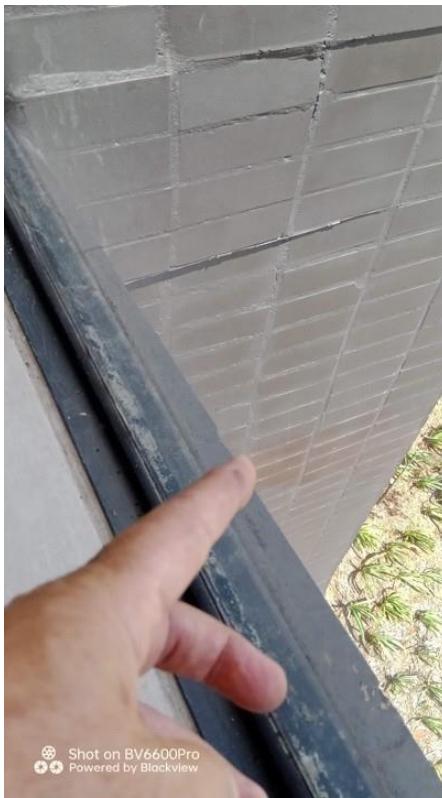
During inspection, it was noted that several windows exhibited scratch marks on the glazing. This occurrence is frequently encountered in newly constructed buildings when contractors overlook the essential precautions for safeguarding the glass during construction activities. It is advised to address these scratches by buffing and polishing them out, ensuring the delivery of a refined and professional product to the client.

Scuff marks from building material on glazing.
