Confidential Inspection Report

LOCATED AT:
Client Address

INSPECTED ON:
Wednesday, 07 February 2024

The Onyx, Umhlanga Ridge Blvd, Flanders, Blackburn

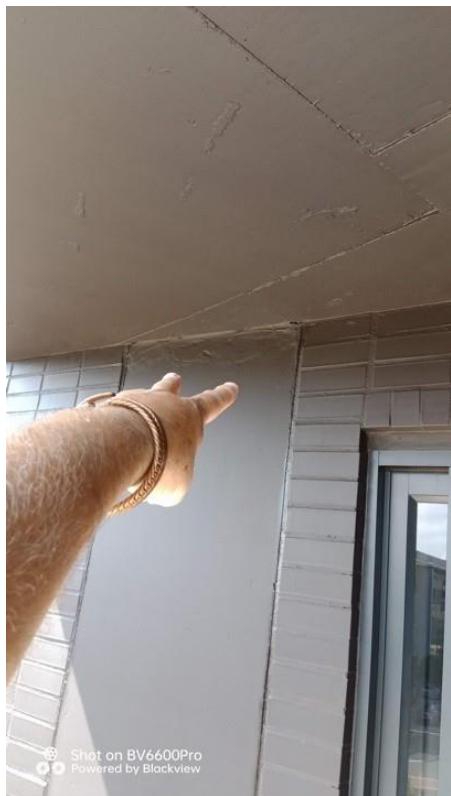
CORR 23: Balcony external painted wall:

The portion of the balcony wall featuring painted plaster exhibits a noticeable lack of professional finishing when juxtaposed with the remainder of the exterior surface. We advise the removal of the existing plaster, followed by reapplication to align seamlessly with the surrounding wall. Subsequent steps should include priming and repainting for a cohesive and uniform appearance.

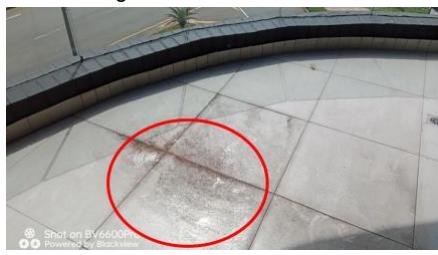
MON 25: There is evidence of ponding on one or more areas of the flat balcony. The presence of shallow ponds of water immediately after rains is not unusual, but regular maintenance of these areas is vital to avoid a buildup of rotting vegetation, dirt, debris and so on. Ponding also leads to deterioration of the balcony finishes and surrounding surface.

Ponding on a Tiled Balcony

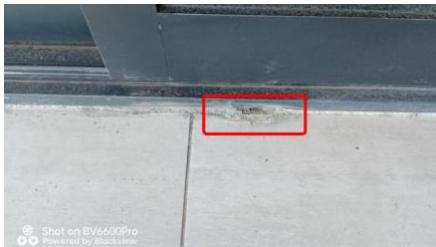
COSM 27: In several places, the grouting is failing between the tiles and around the edges between the tiles and doors. Cracking, chipping, and missing grout are visible in these places, which opens a channel for water to seep through which can lead to loosening of the tiles and damage to the waterproof membrane.

In this case, moisture has seeped into the floor slab. Water is marking the underlying ceiling and dripping onto the patio surface below. Unabated moisture flow through the floor slab can lead to further damage like blistering paint, efflorescence and general damage to the underlying surfaces. In more extreme cases moisture in the slab can also lead to corrosion of the reinforcement bars within the cement slab.

Balcony - grouting between tile and sliding door frame.

We recommend replacing all damaged grout and sealing all gaps with an expandable polyurethane sealant.

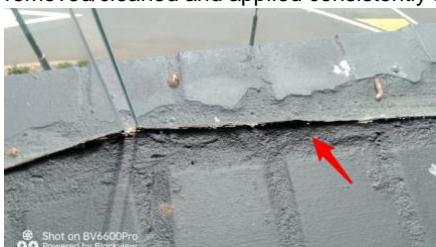
CORR 29: The caulking at the base of the glass guard rail in our opinion was not professionally finished. We recommend the caulking be removed/cleaned and applied consistently and professionally.

Balcony Guard Rail - Caulking substandard

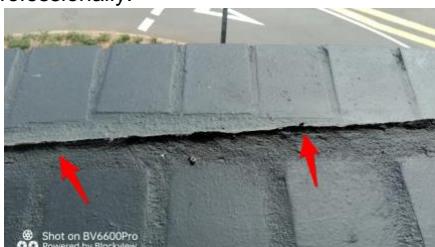
Balcony Guard Rail - Caulking substandard.

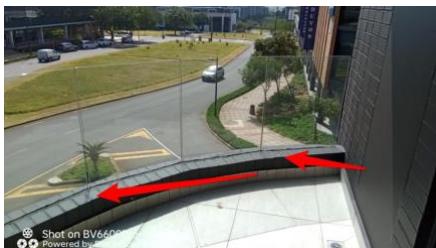
Balcony Guard Rail - Caulking substandard.

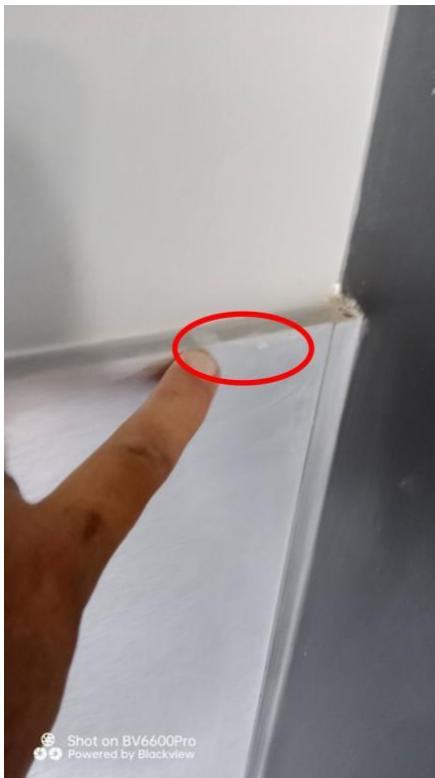
Paint spills on wall tile.

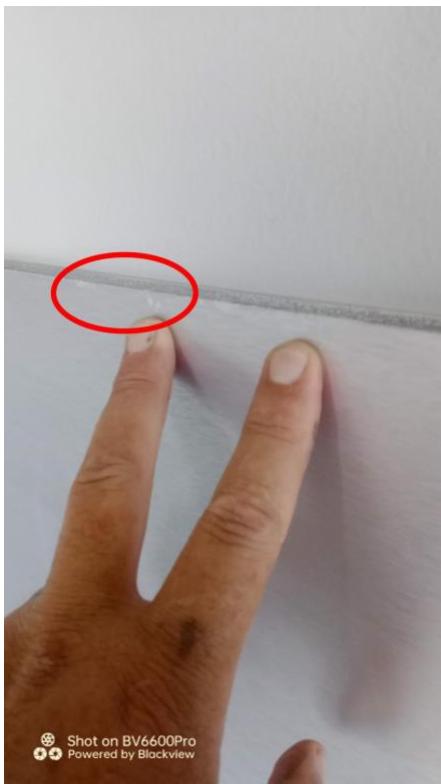
Paint spills on wall tile

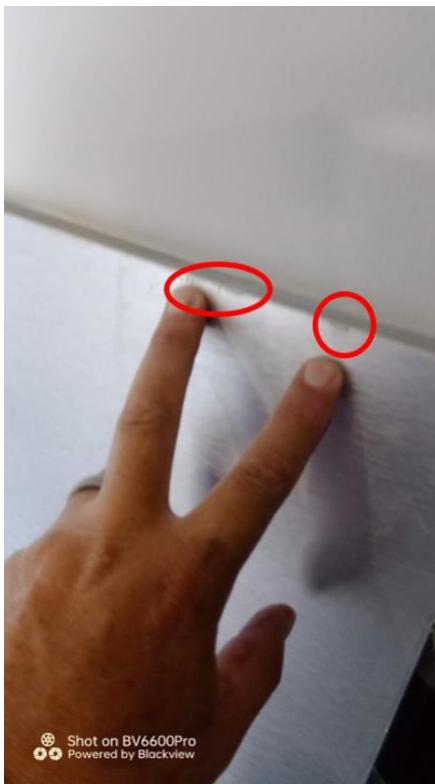
Paint spills on wall tile.

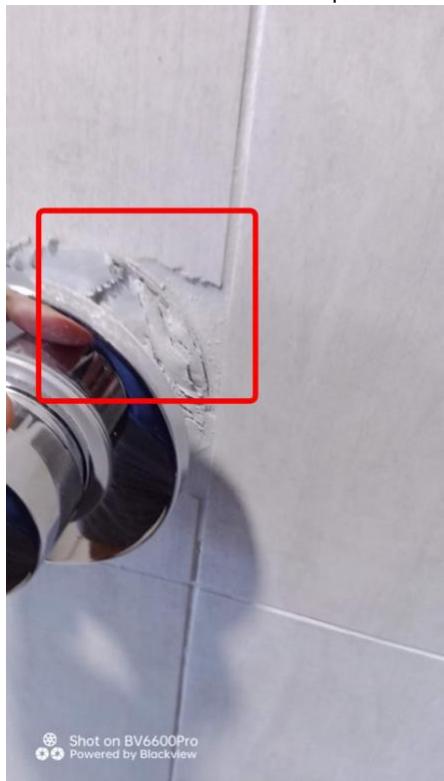
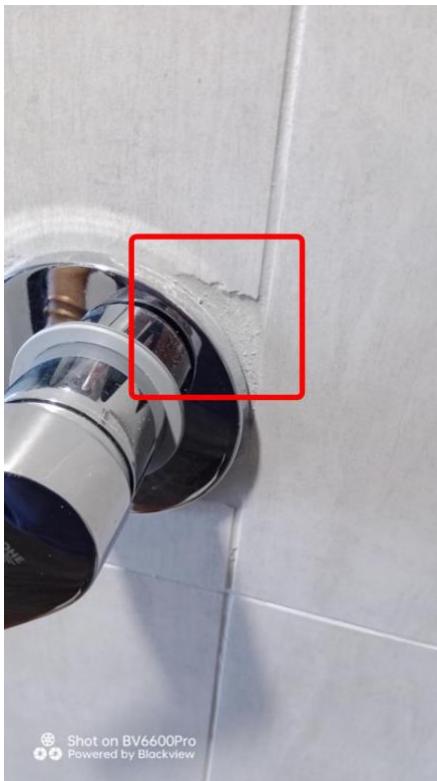
Spare bathroom shower

CORR 43: There are one or more wall tiles that have not been professionally installed near the shower escutcheon. We recommend the tiles be removed and reinstalled professionally in this area.

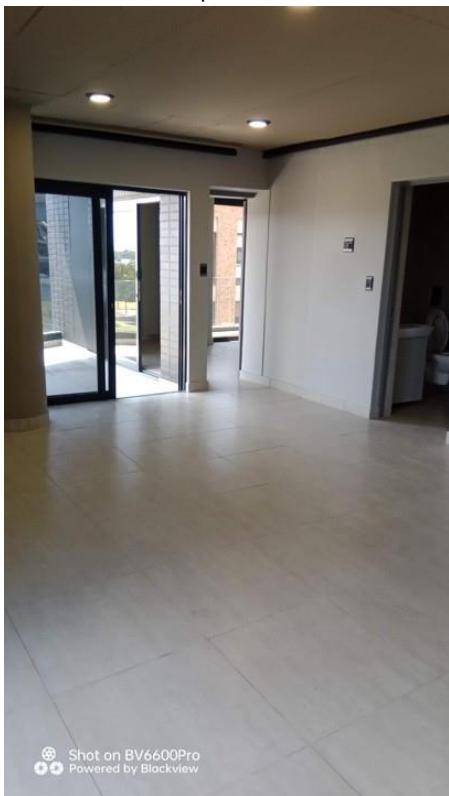
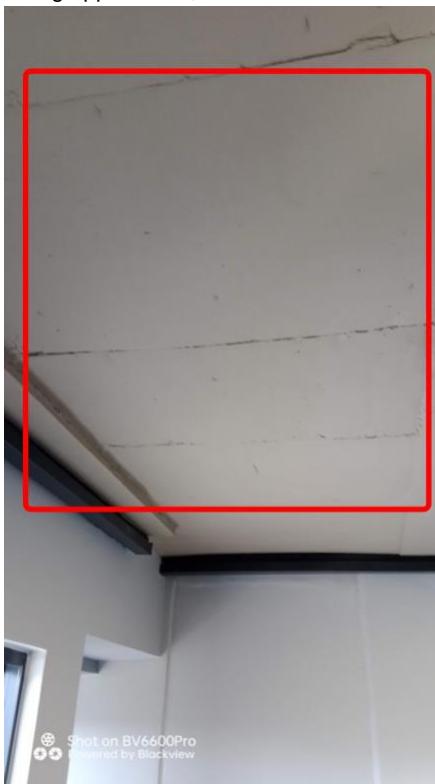
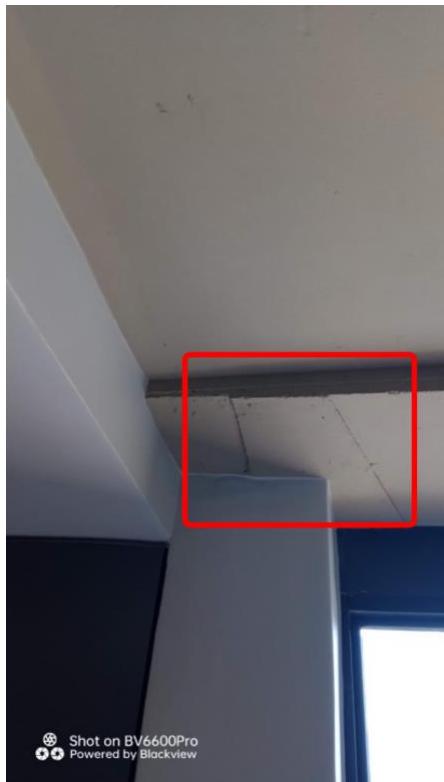
Main living area ceiling

The 'finished' ceiling, constituting the reinforced slab between the floors coated with paint, displays noticeable inconsistencies in its levels as noted by the inspector. The client should inquire with the builder/developer regarding whether these irregularities conform to the intended design specifications.

To achieve a more polished and aesthetically pleasing appearance, we recommend the installation of a suspended ceiling

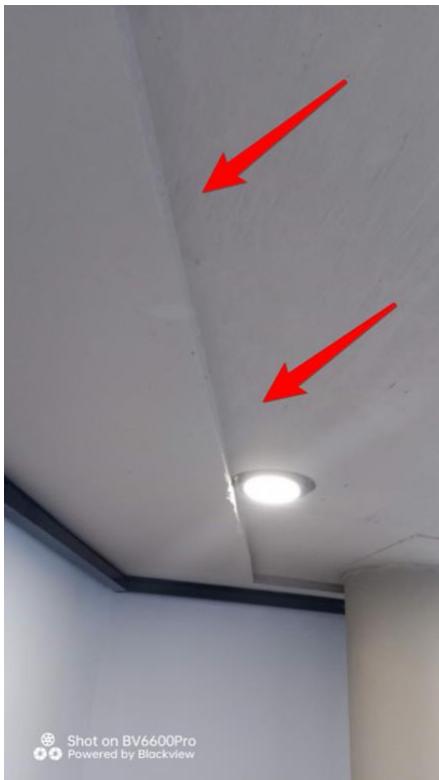
Stepped concrete ceiling

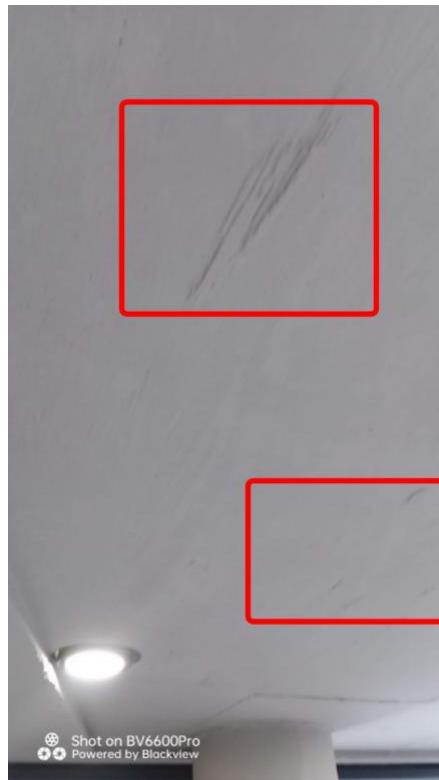
Ceiling Blemishes

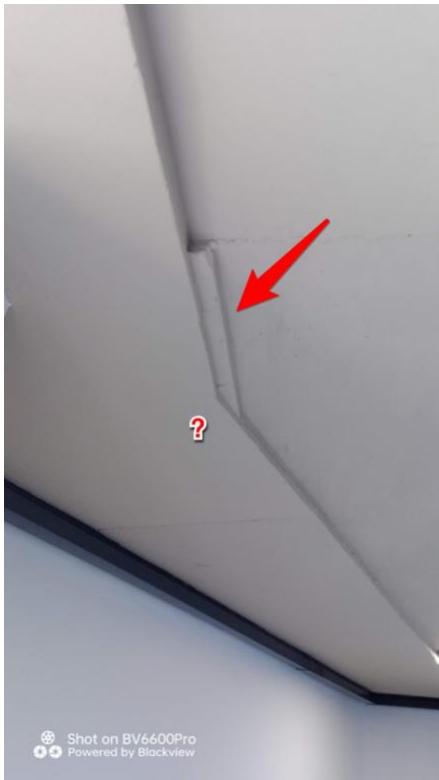
Ceiling Blemishes

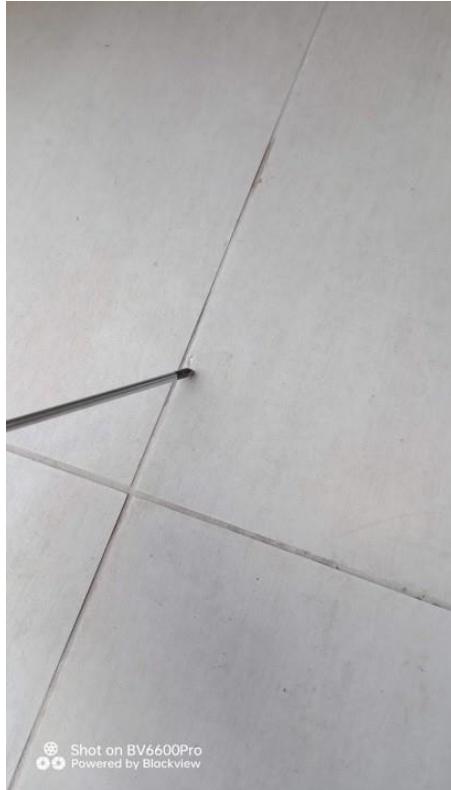
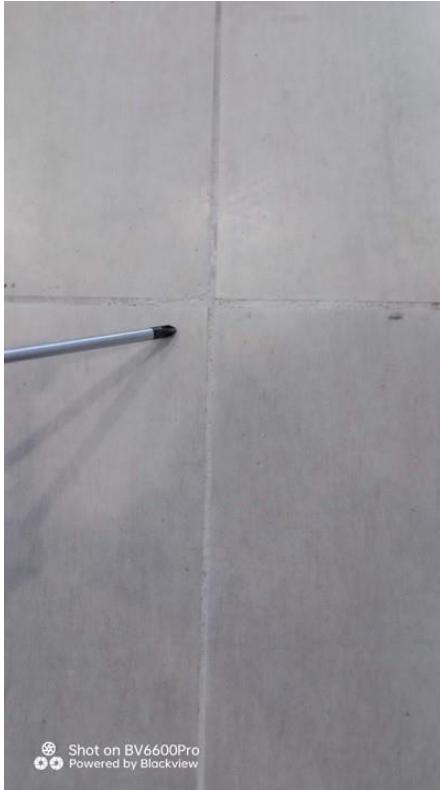
Main Living area - left facade

CORR 49: Several tiles sound 'hollow' when walked on pointing to substandard preparation and installation of tiles. These tiles will be more likely to crack and break, therefore since repairing this issue is not possible, replacement is the only solution.

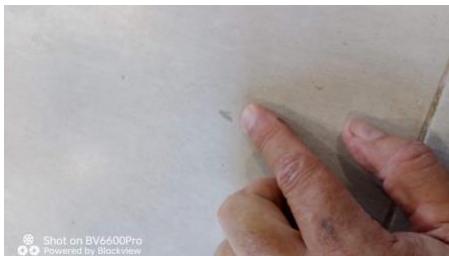
Paint splash marks on the finished tile.

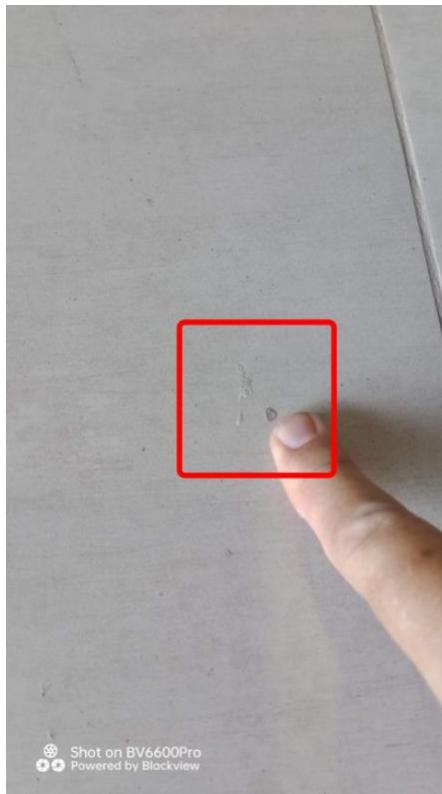
Paint Splash Marks on the finished tile.

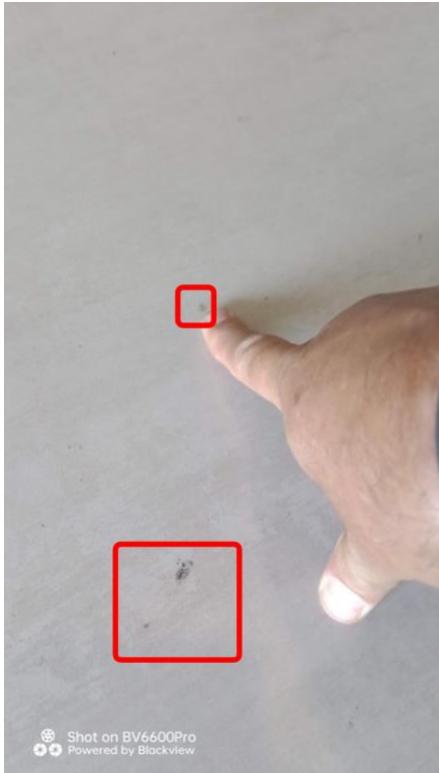
Paint splash marks on the finished tile.

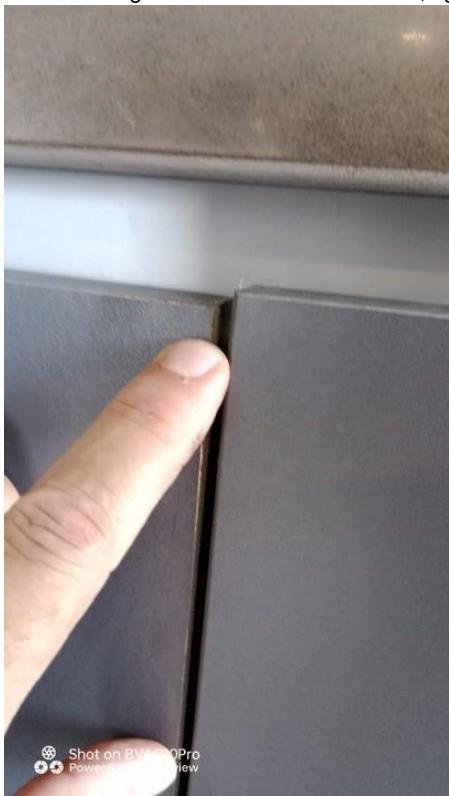
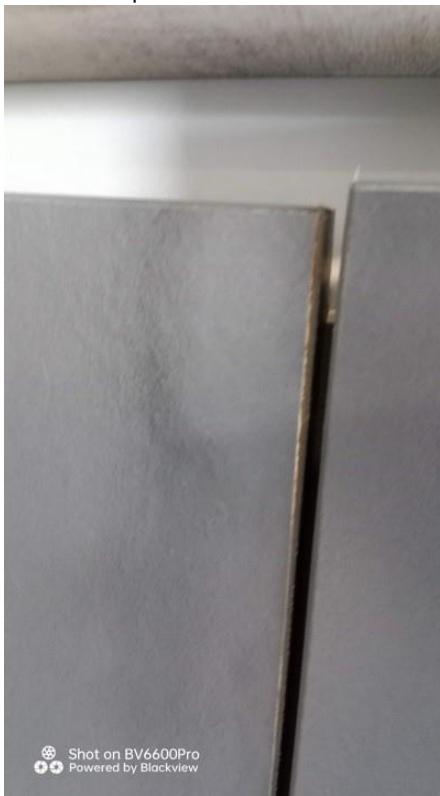
CORR 52: One of the kitchen cabinets needs to be aligned for proper operation. It could be loose hinges and we recommend the door hardware in general needs to be checked, tightened and/or replaced.

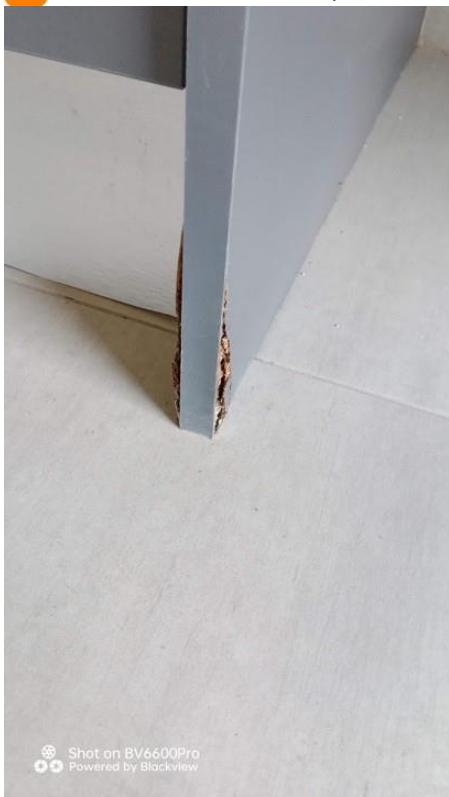
CORR 53: The cabinets and/or cupboards are damaged. We recommend repair to restore appearance and proper function.

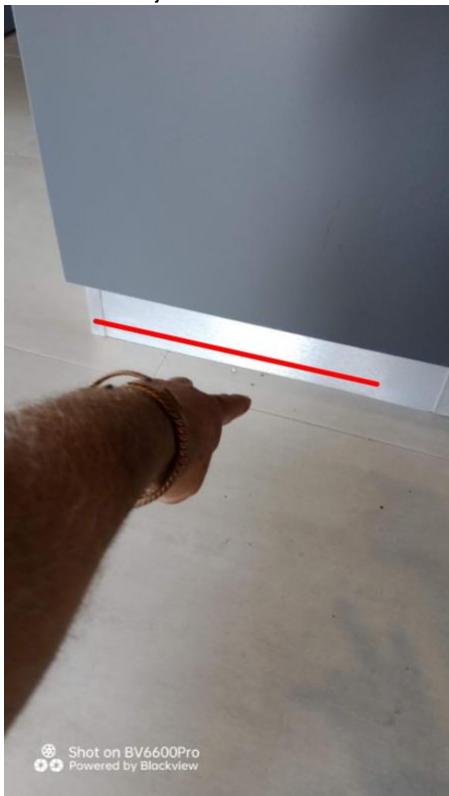
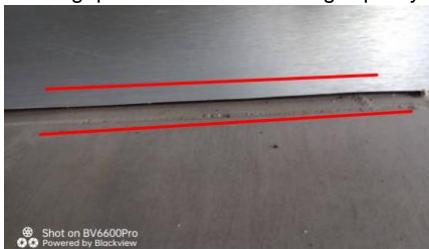
CORR 54: There are gaps between the cupboard and the kick plate under the cupboard, pointing to substandard installation or damage. We recommend adjustments are made if necessary and all gaps are sealed with a high-quality neutral cure sealant like 'Soudal Silirub 2'.

Kitchen kick-plate - seal off so no water damage occurs.

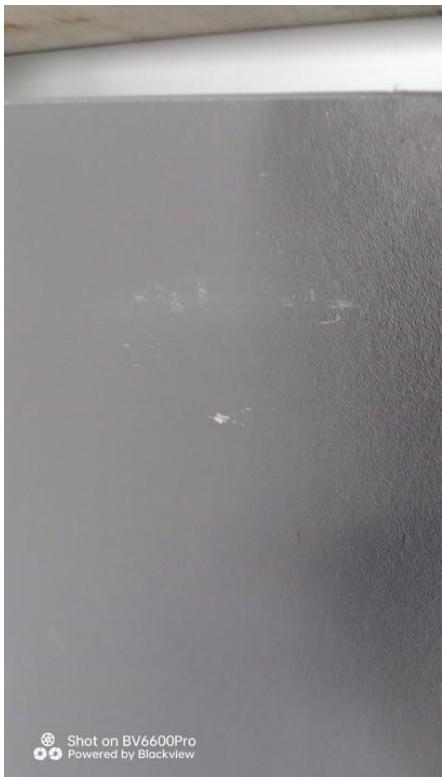
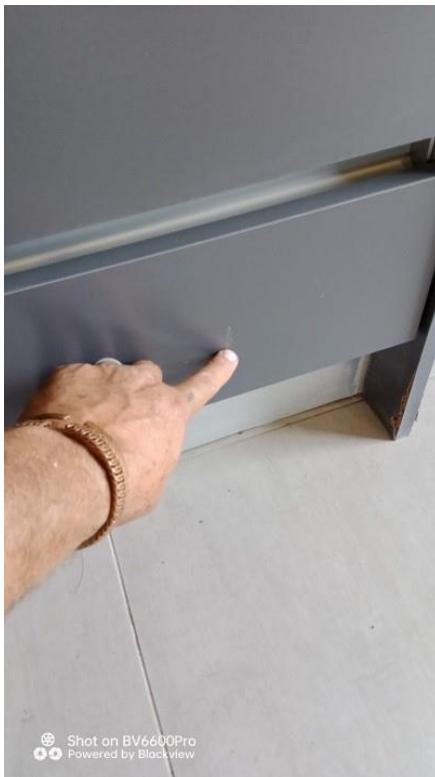
CORR 56: Scuff marks on the kitchen cupboard.

The inspector noticed several scuff marks left behind by the contractors. As this is a new build and a snag list inspection, all building systems and components should be new. Our recommendation is that all doors and or cupboards where scuff marks exist cannot be repaired/cleaned then replacement should be the final step of remediation

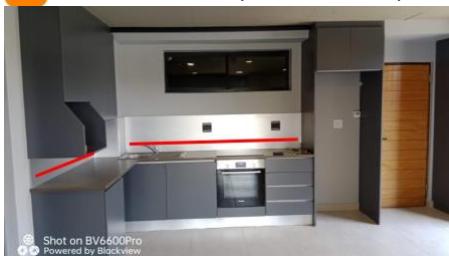
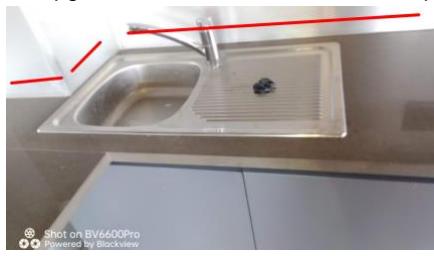
CORR 58: The countertop lacks a backsplash. As an upgrade, we recommend that a backsplash be installed.

Absent - Backsplash

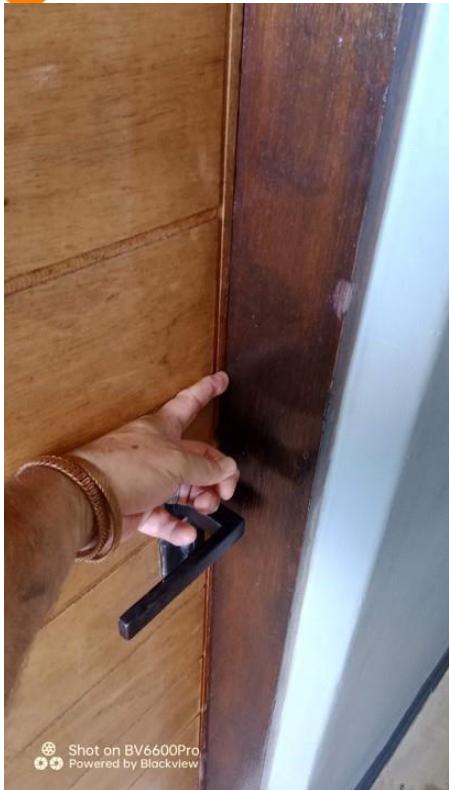
CORR 63: Several of the doors are a poor fit

and have uneven gaps. This is a common occurrence.

The front door is not aligned-
rattles.

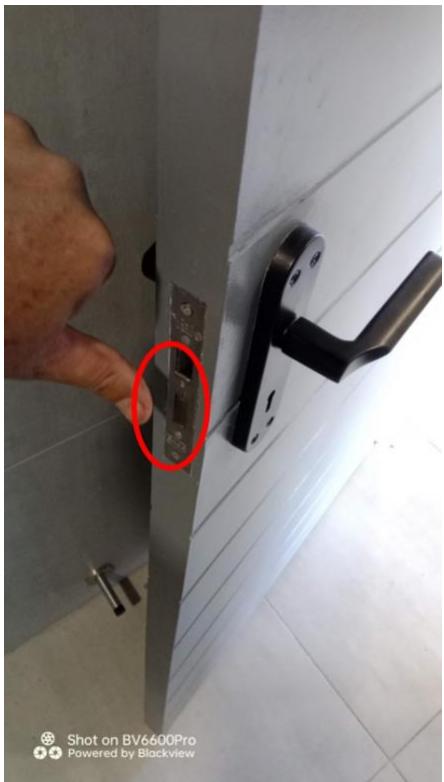
Spare bathroom

CORR 64: There are one or more doors where hardware is faulty and needs attention, repair, or replacement.

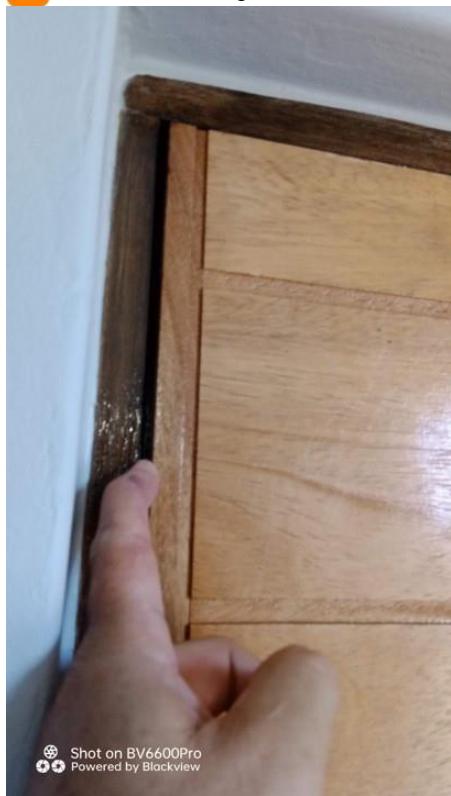
CORR 65: The weather guard fitted to one or more doors are loose and need to be tightened for optimal use.

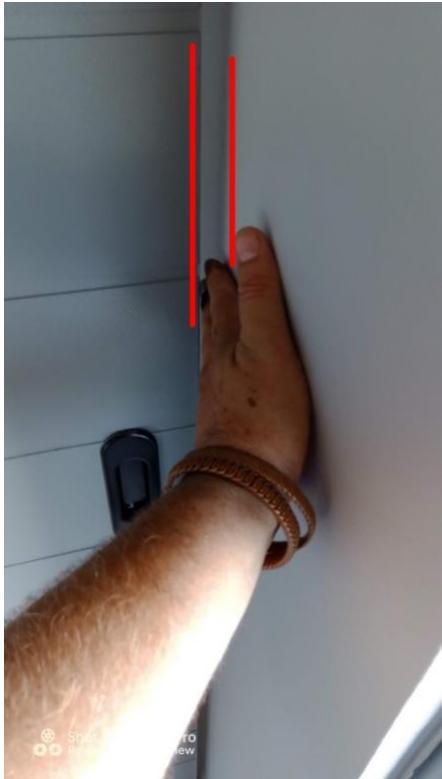
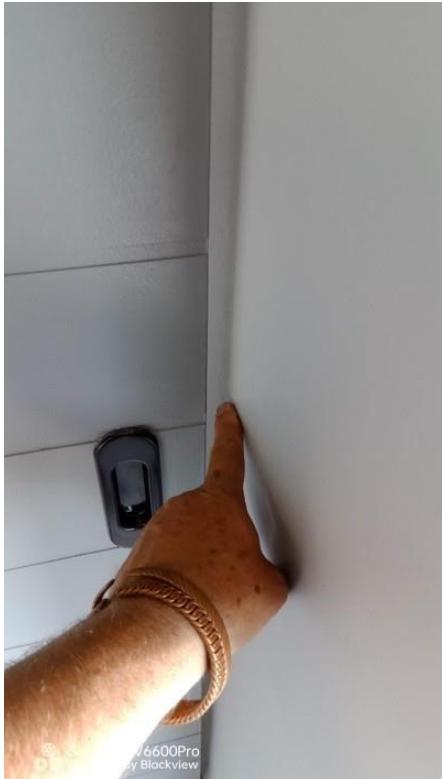
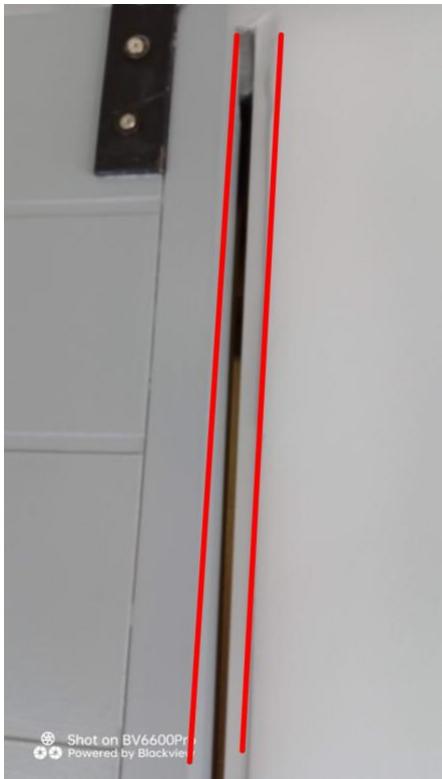
Master bedroom - barn door

The barn door leading into the master bedroom does not close tightly with the frame. There is approximately a 3/4-inch space between the frame and the edge of the door. We recommend this be repaired.

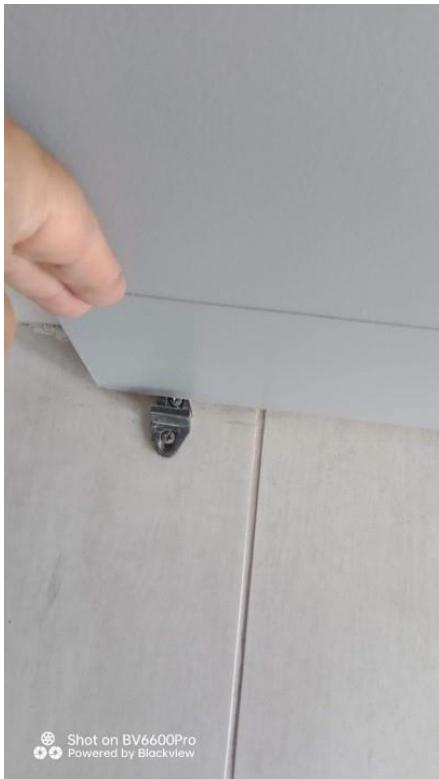
The floor mount is loose creating a rattling noise when opening or closing the barn door. We suggest this be tightened.

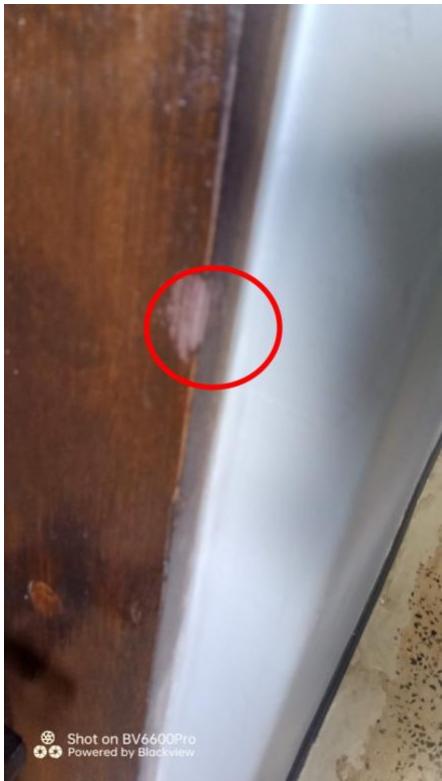
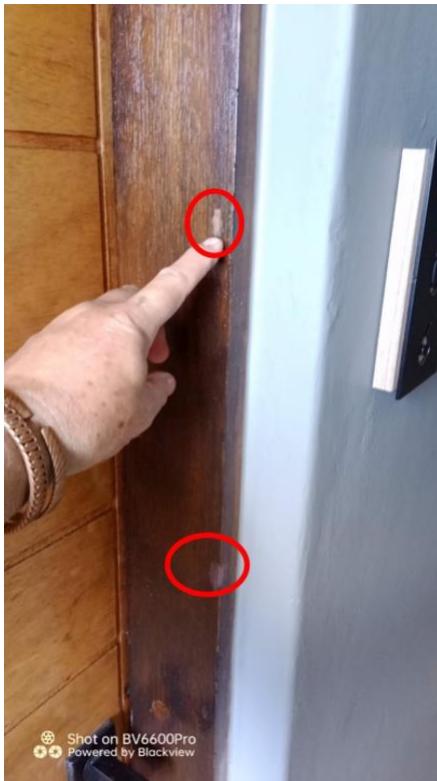
Front door

CORR 68: Wooden door frame scuff marks present:

The inspector noticed several scuff marks on the wooden door frame. As this is a new apartment, we would recommend this be repaired by the developer.

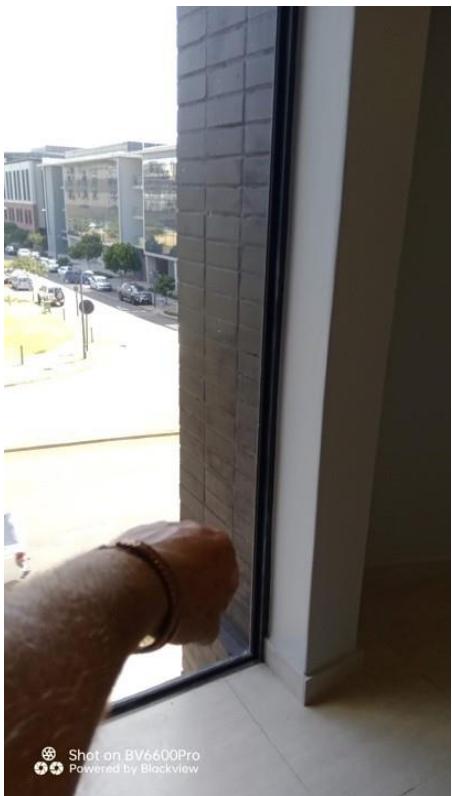
Main window - living area

HAZ MON 72: Glass Hazard Advisory:

During the inspection of the apartment, the inspector observed notable movement and rattling of the large windowpane, potentially influenced by the prevailing strong winds. Although the inspector's expertise does not extend to glass and frame assessment, it is highly recommended to consult an independent glass specialist for evaluation. This assessment is crucial to determine if the observed movement and vibration adhere to building standards and ensure the safety of the occupants.

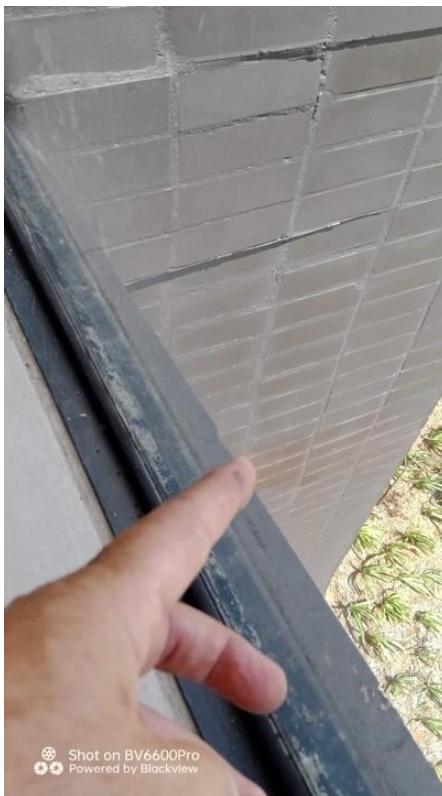
During inspection, it was noted that several windows exhibited scratch marks on the glazing. This occurrence is frequently encountered in newly constructed buildings when contractors overlook the essential precautions for safeguarding the glass during construction activities. It is advised to address these scratches by buffing and polishing them out, ensuring the delivery of a refined and professional product to the client.

Scuff marks from building material on glazing.
